NATIONAL TRANSPORTATION SAFETY BOARD

POWERLINE INFORMATION (Rev B)

**NTSB Accident: WPR17FA013
Accident Date: October 25, 2016**

Location: Pittsburg, California
Date: October 25, 2016
Aircraft: Beechcraft A-36 'Bonanza', N364RM, Serial # E-2957
NTSB IIC: Michael Huhn

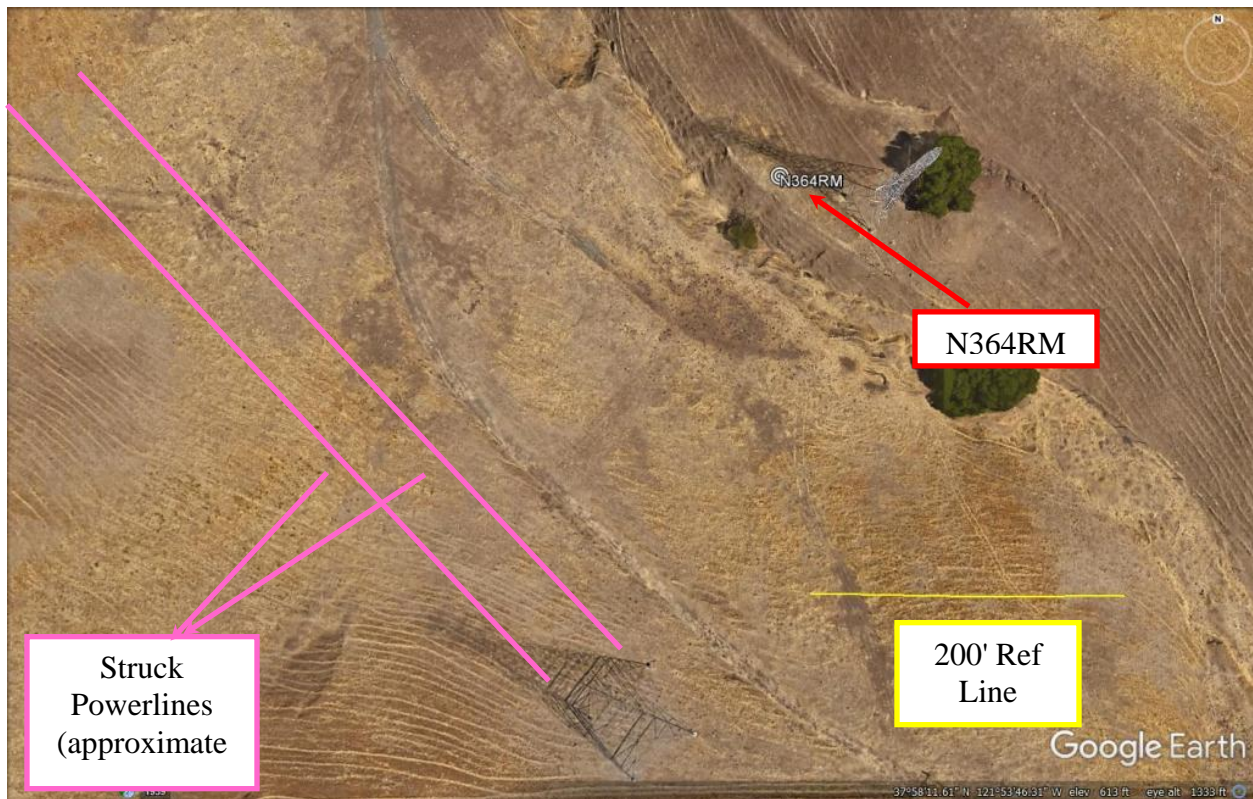
Figure 1 - Powerline and Ground Impact Orientation

- Geographic Coordinates
 - 37° 58' 12.95" N
 - -121° 53' 45.24" W
- Site elevation was approximately 590 feet MSL
- The impact location was about 7.95 miles from the departure (south) end of KCCR runway 19R, on a bearing of 095° true (~081° magnetic) from that runway end
- The main impact site was located about 310 feet (horizontally) from the first powerline strike, on a bearing of 038° true (~024° magnetic)

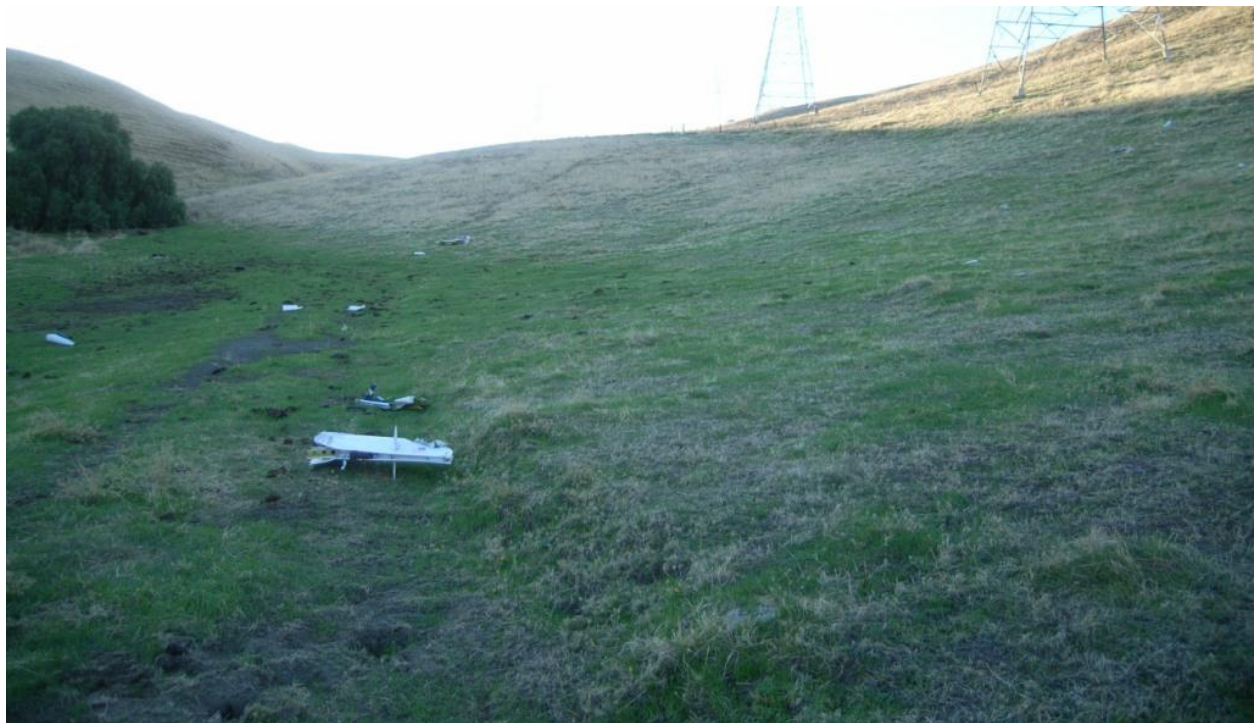
Figure 3 - Powerline Strike Debris

The airplane struck two high tension powerlines and then the ground. The powerlines were oriented approximately perpendicular to the flight path, and were struck about 300 feet prior to the ground impact point. About 50 fracture-separated sections of the airplane, consisting primarily of empennage and right wing fragments, were scattered below the powerlines, and in the field between the powerlines and the impact site. A post impact fire consumed most of the airplane at the impact site.

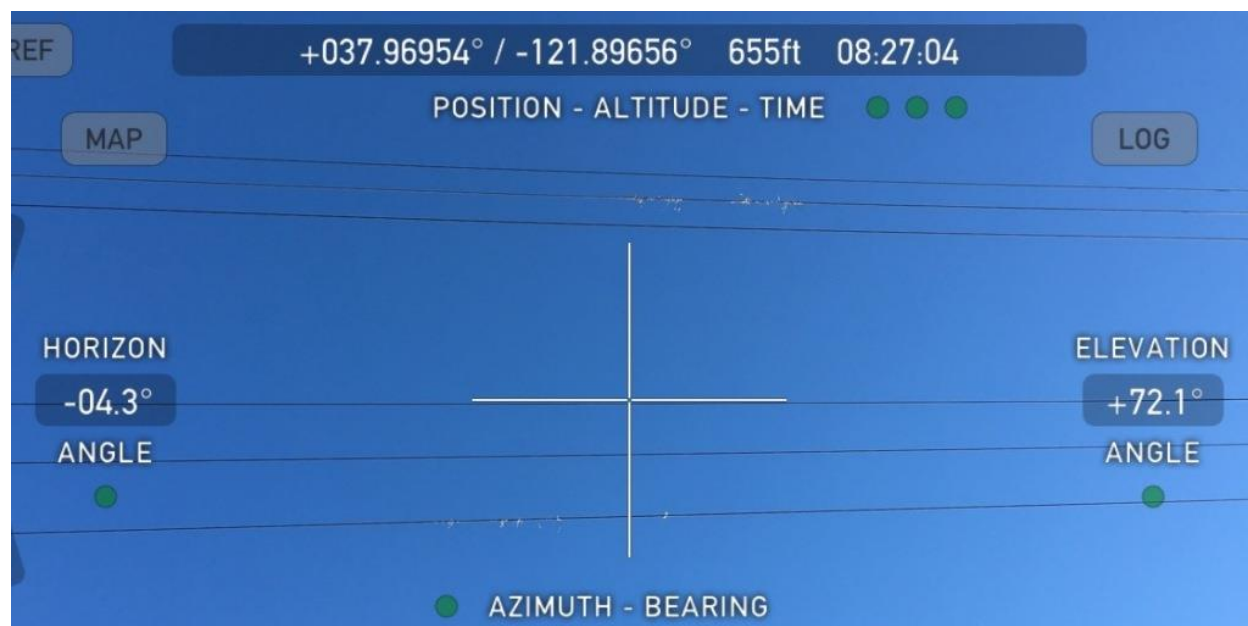
Figure 4 - Damaged Powerlines

The first struck powerline exhibited three discontinuous/separate damage sites, over a span of approximately 25 feet. The second struck powerline exhibited three discontinuous/separate damage sites, over a span of approximately 12 feet.

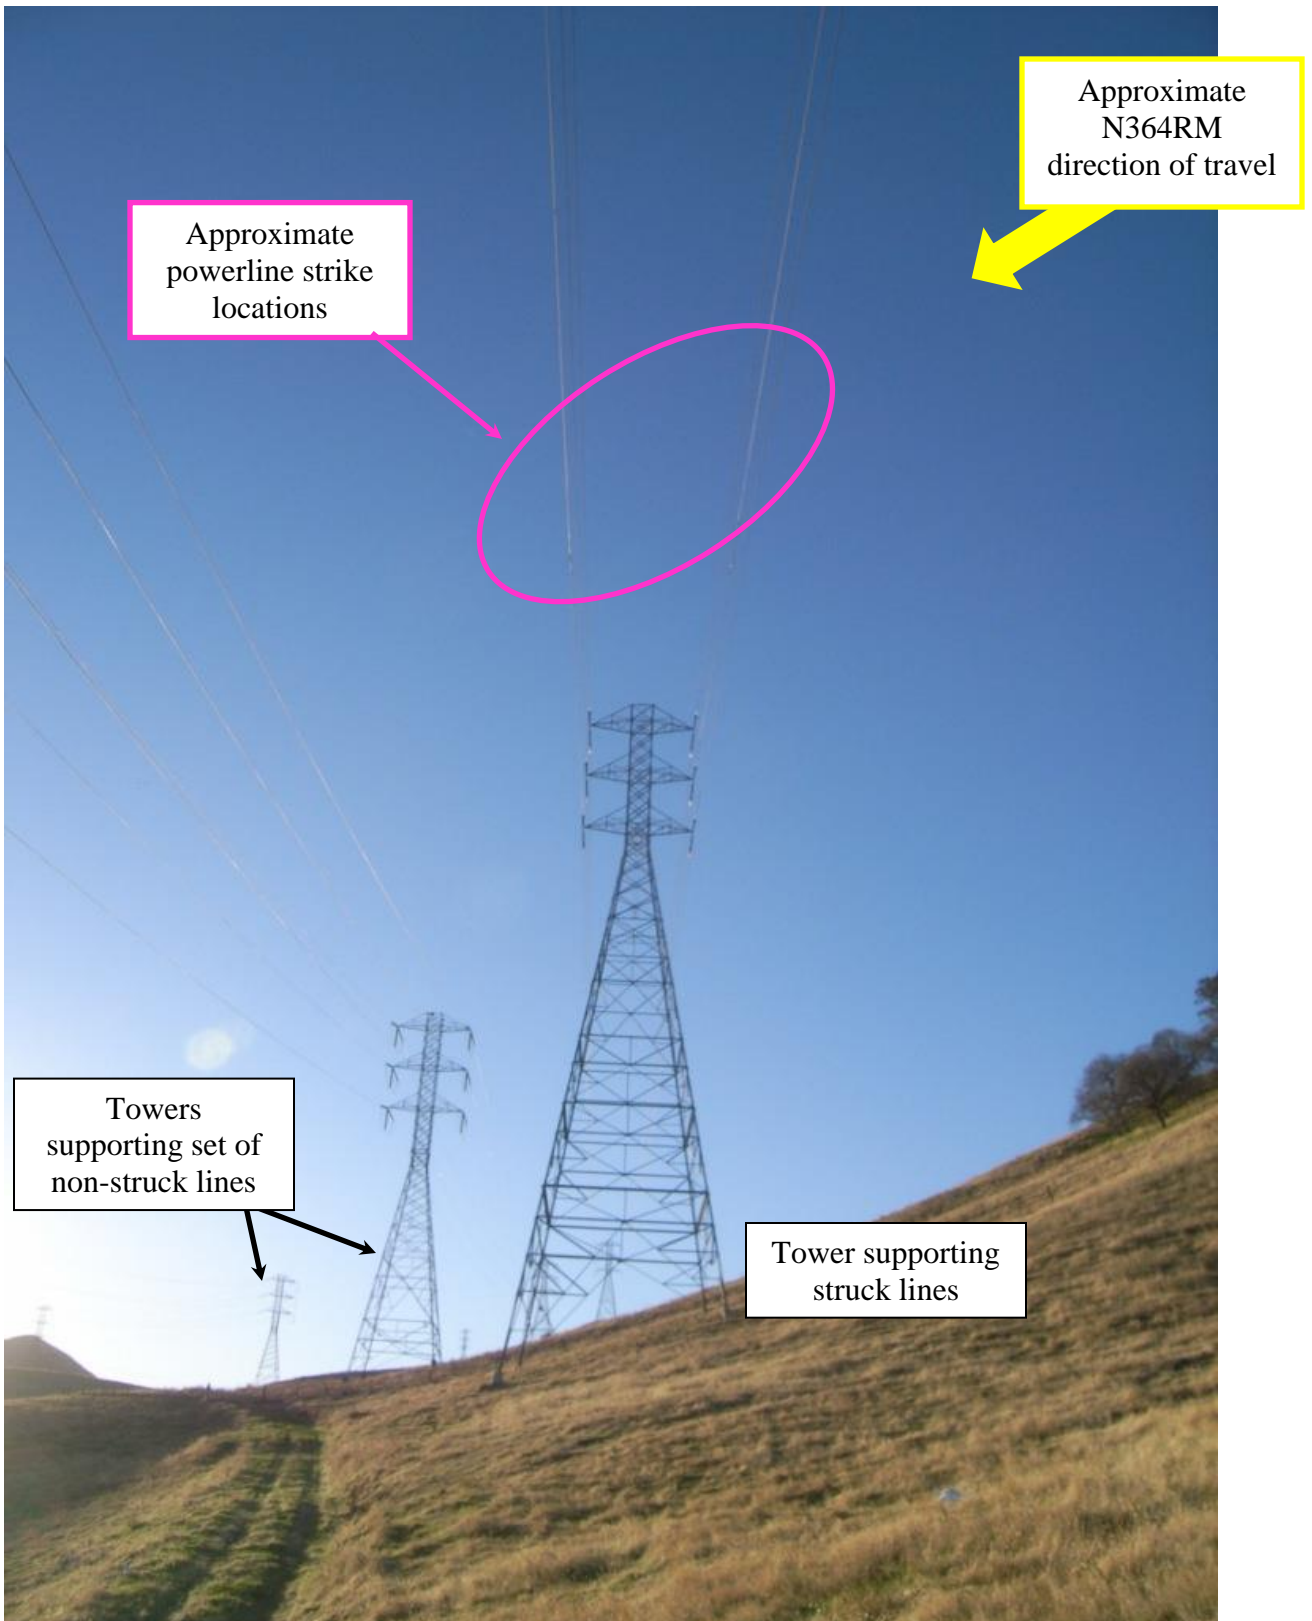
Figure 5 - Powerline Arrangement

The airplane struck and damaged two Pacific Gas & Electric (PG&E) high tension powerlines prior to ground impact. The powerlines were oriented approximately perpendicular to the flight path, and consisted of 6 lines total, with 3 lines on either side of the supporting tower. According to a PG&E representative, the tower was 170 feet high, the highest conductors were at a height of 165 feet (at the tower), and the vertical separation between conductors was about 16 feet. Investigators estimated the horizontal separation of the conductors to be about 40 feet. The airplane struck the wires about 130 feet from the tower; cable catenary sag was estimated to be about 5 feet at the struck location. The airplane first struck the middle line of the PG&E Pittsburg-San Mateo 230kVa array, and then the lower line of the PG&E Pittsburg-East Shore 230kVa array. Although neither line was severed, both were damaged. A second, similar array of 6 more powerlines, was situated just northeast of, and parallel to, the struck set. None of those second 6 powerlines were struck.
